ENFORCEMENT ACTION AGAINST OSO BAY	§	BEFORE THE
APARTMENTS, LLC, MERCED ROSARIO	§	TEXAS DEPARTMENT OF HOUSING
HOUSING PARTNERS, LP, AND	§	AND COMMUNITY AFFAIRS
APARTMENTS OF LAS PALMAS I, LLC, WITH	§	
RESPECT TO OSO BAY (HTC 20620 / BOND	§	
20620B / CMTS 5670), LA MERCED HOMES	§	
(HTC 21424 / CMTS 5733), EL ROSARIO	§	
HOMES (HTC 21423 / CMTS 5732), AND LAS	§	
PALMAS APARTMENTS (HTC 21438 / CMTS	§	
5727)	§

AGREED FINAL ORDER

Exhibit 1
La Merced Final Construction Inspection Deficiency List

Exhibit 2
El Rosario Final Construction Inspection Deficiency List

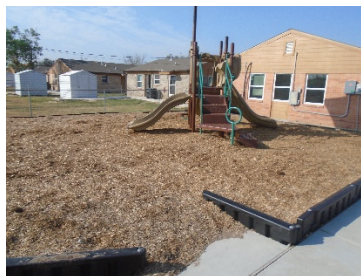
Item #3 Deficiency: Accessible Walking Surface (2010 ADA 206.3, 302, 403.3) This development is subject to ADA design requirements. The ground surface along accessible routes near the playground does not meet the minimum surface conditions required for an accessible walking surface.

- **Corrective Action** – Please provide an architect’s or accessibility specialist’s certification with photographic evidence that the condition has been corrected throughout the property, not including areas of sport activity, within animal containment areas, or children’s play areas. The certification must verify that walking surfaces in accessible rooms and spaces, along accessible routes, and within required clear floor spaces, wheelchair maneuvering spaces, and turning spaces are: **1) firm, stable, and slip resistant**; Note that well-drained, compacted crushed granite, or smooth pavers with no abrupt level changes are acceptable surfaces.

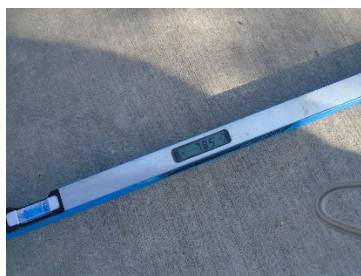
Item #4 Deficiency: Accessible Route Cross Slope (2010 ADA 403.3). This development is subject to ADA design requirements. The accessible pedestrian route near the office has a cross slope that exceeds the allowed maximum for any slope that runs perpendicular to the direction of travel along the accessible route. The cross slope was 7.85.

- **Corrective Action** – Please provide an architect’s or accessibility specialist’s certification with photographic evidence that the condition has been corrected at the location cited and throughout

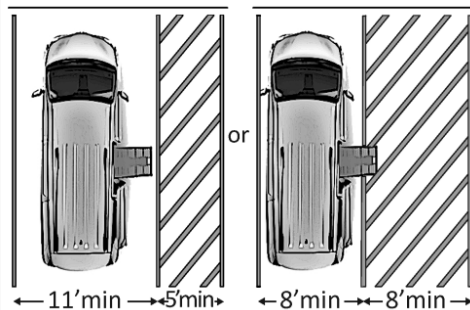
Item #5 Deficiency: Accessible Van Parking Space (2010 ADA 208.2.4, 502.5) This development is subject to ADA design requirements. The development provides 2 accessible parking spaces, but does not provide the required number of accessible van parking spaces.

- **Corrective Action** – Please provide an owner’s certification with photographic evidence that the condition has been corrected. The certification must verify that at least one van space is provided for every six accessible parking spaces, and that the development provides 1 accessible van spaces. The photographs must show that each van space is at least 132 inches wide, and has a minimum vertical clearance of 98 inches.

Where there are more than four accessible parking spaces in the development and where all spaces are not assigned to specific residential dwelling units, ensure that a vertically mounted sign is provided that includes the International Symbol of Accessibility and designates that the parking space is reserved for accessible parking and contains the designation “van accessible.” Ensure that the sign is at least 60 inches above the finish floor or ground surface measured to the bottom of the sign. Also ensure that an adjacent, level surface, unobstructed access aisle (no carport post or built-up ramp) that is at least 60 inches wide and is connected to the accessible route is provided (one aisle may be shared between two adjacent accessible parking spaces).

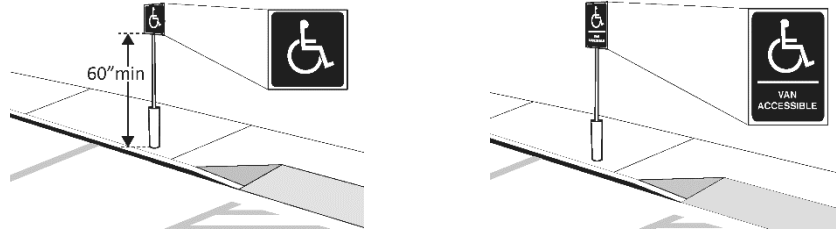
Item #7 Deficiency: Accessible Parking Signs (2010 ADA 216.5) This development is subject to ADA design requirements. The accessible parking space located at the office did not have an accessible parking space identification sign designating the space as reserved for disabled use only.

- **Corrective Action** – Please provide an architect’s or accessibility specialist’s certification with photographic evidence that the condition has been corrected at the location cited. The certification must specifically verify that all accessible parking signs meet the following conditions: 1) signs include the International Symbol of Accessibility; 2) contain the designation “van accessible” for all van spaces; and 3) are mounted at least 60 inches above the floor or ground surface measured to the bottom of the sign.

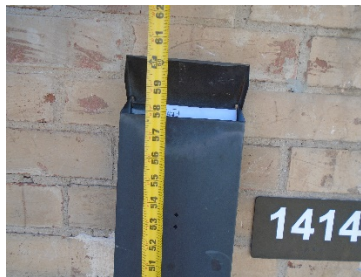
Item #8 Deficiency: Mailboxes (2010 ADA 205, 308-9) The mobility accessible units mailboxes were 58 inches above the ground surface and were not within accessible reach ranges.

- **Corrective Action** – Provide an architect’s or accessibility specialist’s certification with photographic evidence that the mailbox lock at this location and at other accessible unit mailboxes have been corrected or are already correct. The certification should say that they are on an accessible route, and, where the clear floor space is positioned for an (a)unobstructed front (forward) approach, the height of the mailbox lock is 15-48 inches above the ground surface (b)unobstructed side (parallel) approach, the height of the mailbox lock is 15-48 inches.

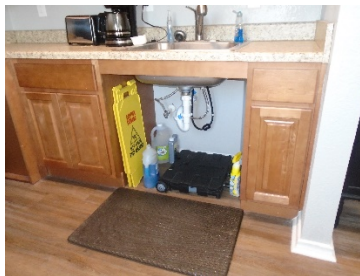
Item #9 Deficiency: Exposed Pipes (2010 ADA 606.5) The office is identified as a common use facility and subject to ADA design requirements. The kitchen sink does not provide adequate protection from exposed pipes and sharp or abrasive surfaces under the sink that may cause injury to certain users.

- **Corrective Action** – Please provide an architect’s or accessibility specialist’s certification with photographic evidence that the condition has been corrected at the location cited. The certification must verify the following: 1) water supply and drain pipes under sinks are insulated or otherwise configured to protect against contact; 2) there are no exposed sharp or abrasive surfaces under the sink; and 3) the minimum clearance beneath the sink is: (a) knee space is 8 inches deep (measured horizontally from the front edge of the sink counter) at a point that is 27 inches above the floor; (b) leg clearance is 11 inches deep at a point 9 inches high; and (c) toe clearance is at least 17 inches deep a point at least 9 inches high.

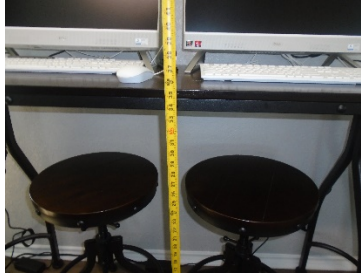
Item #10 Deficiency: Tables & Work Surfaces (2010 ADA 226, 902) The Office is identified as a common use facility and subject to ADA design requirements. The common use computer desk at the business center does not provide an accessible height working surface.

- **Corrective Action** –Please provide an architect’s or accessibility specialist’s certification with photographic evidence that the condition has been corrected at the location cited. The certification must verify that at least 5% of all common use work surfaces on the property(ADA) and specifically verifies that the following design features are provided for each accessible work surfaces: 1) a minimum 30 inch by 48 inch clear floor or ground space provides one unobstructed side located adjacent to the accessible route for the property, and is positioned for a forward (front) approach; 2) top surface is 28 to 34 inches high; and 3) open space beneath accessible tables and work surfaces provides the required knee, leg and toe clearances.

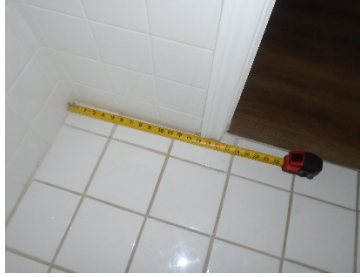
Item #12 Deficiency: Door Maneuvering Clearance (2010 ADA 404.2.4, 809.2) Units 99 and 98 are designated as mobility accessible dwelling units and subject to ADA design requirements. The bathroom door does not provide an unobstructed landing or floor space for maneuvering on the interior side that is of the required dimensions for the approach conditions for a passage door on an accessible route. Additional mobility accessible dwelling units were not inspected but may also be affected.

- **Corrective Action** – Provide an owner’s certification with photographic evidence (one sample photo only) that the condition has been corrected in the cited units and all other mobility accessible dwelling units. Ensure that the door at this location and at all other interior and exterior passage doors on accessible routes provide a landing or floor surface area on both sides of the door that is unobstructed and level (max. 2% slope) within the perimeter dimensions illustrated below. This includes a clear floor area that extends 18 inches beyond the latch side of a door that must be pulled to open (see upper left diagram). This includes a 48 inches wide hallway at doors that swing into the hall if the approach is from the latch-side, and 54 inches wide if from the hinge-side (see middle and lower left diagrams).

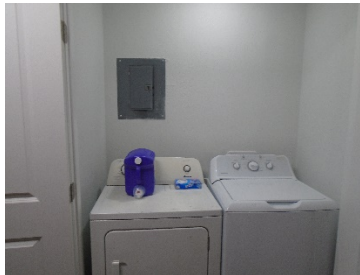
Item #13 Deficiency: Operable Parts (2010 ADA 205, 308-9) Units 99 and 98 are identified as mobility accessible dwelling units and subject to ADA design requirements. The unit breaker box switch is not within accessible reach ranges. Additional mobility accessible dwelling units were not inspected but may also be affected.

- **Corrective Action** – Provide an architect’s or accessibility specialist’s certification with photographic evidence that the breaker boxes at the cited unit and all other mobility accessible dwelling and units have been corrected or are already correct. The certification must verify that accessible breaker boxes and are on an accessible route, and, where the clear floor space is positioned for an **(a)**unobstructed front (forward) approach, the height of the switch is 15-48 inches above the floor **(b)**unobstructed side (parallel) approach, the height of the switch is 15-48 inches above the floor (an object that is less than or equal to 34 inches high and less than or equal to 10 inches deep is not considered an obstruction).

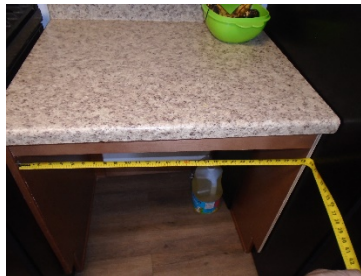
Item #14 Deficiency: Work Counter (2010 ADA 804.3, 804.6.5) Unit 98 is designated as a mobility accessible dwelling unit and subject to ADA design requirements. The kitchen does not provide an accessible work counter with a minimum 30” wide accessible open knee space or removable cabinet beneath. Additional mobility accessible dwelling units were not inspected but may also be affected.

- **Corrective Action** – Provide an architect’s or accessibility specialist’s certification with photographic evidence that the condition has been corrected in the cited unit and all other mobility accessible dwelling units. The certification must verify that all accessible work counters meet the following conditions: 1) the counter height is no more than 34 inches above the floor; 2) an unobstructed 30 inch by 48 inch floor space is positioned to provide a forward (perpendicular) approach, with the 48 inch dimension measured from a point under the counter that is no more than 19 inches back from the front edge of the counter; 3) the work surface is positioned adjacent to one side of the bottom-hinged oven; 4) the minimum clearance beneath the counter is: (a) knee space is 8 inches deep (measured horizontally from the front edge of the counter) at a point that is 27 inches above the floor; (b) leg clearance is 11 inches deep at a point 9 inches high; and (c) toe clearance is at least 17 inches deep at a point at least 9 inches high; 5) any base cabinetry that conceals the knee, leg, and toe clearance below the counter is quickly and easily removable without removal or replacement of the counter or surrounding structure, the walls behind and surrounding the cabinetry are finished, and the finish floor extends under the cabinetry.

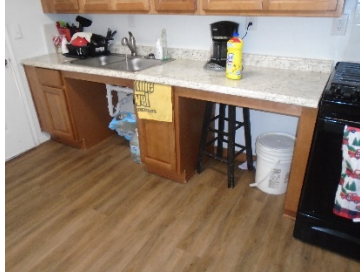
Item #15 Deficiency: Exposed Pipes (2010 ADA 606.5) Unit 99 is designated as a mobility accessible dwelling unit and subject to ADA design requirements. The accessible kitchen sink does not provide adequate protection from exposed pipes and sharp or abrasive surfaces under the sink that may cause injury to certain users. Additional mobility accessible dwelling units were not inspected but may also be affected.

- **Corrective Action** – Provide an architect’s or accessibility specialist’s certification with photographic evidence that the condition has been corrected in the cited unit and all other mobility accessible dwelling units. The certification must verify the following: 1) water supply and drain pipes under sinks are insulated or otherwise configured to protect against contact; 2) there are no exposed sharp or abrasive surfaces under the sink; and 3) the minimum clearance beneath the sink is: (a) knee space is 8 inches deep (measured horizontally from the front edge of the sink counter) at a point that is 27 inches above the floor; (b) leg clearance is 11 inches deep at a point 9 inches high; and (c) toe clearance is at least 17 inches deep a point at least 9 inches high.

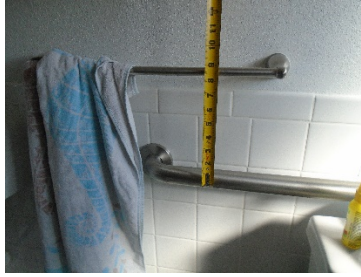
Item #16 Deficiency: Grab Bar Height & Clearance (2010 ADA 609, 609.4) Unit 99 is designated as a mobility accessible dwelling unit and subject to ADA design requirements. The grab bars at the toilet in the bathroom does not provide the required minimum clearance. Additional mobility accessible dwelling units were not inspected but may also be affected.

- **Corrective Action** – Please provide an architect’s or accessibility specialist’s certification with photographic evidence that the condition has been corrected in the cited unit and all other mobility accessible dwelling units. The certification must verify that grab bars meet each of the following conditions: 1) grab bars are securely-mounted and do not rotate in their fittings; 2) are 1¼ inches to 1½ inches in diameter; 3) grab bars located in the positions that are specified for grab bars at toilets, showers and bathtubs are mounted with the center of the bars at 33 inches to 36 inches above the floor (except the lower grab bar at the back wall of bathtubs); 4) all grab bars located in the positions that are specified for grab bars at toilets, showers and bathtubs are mounted horizontally; and 5) all specified and non-specified grab bars provide at least 1½” of clearance between the grab bar and any obstruction and 12 inches minimum from the grab bars and any protruding object above it (e.g., soap dish, spray unit bar, valve, and other bars).

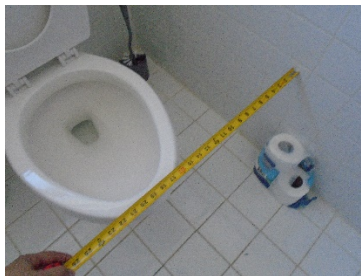
Item #17 Deficiency: Toilet Placement/ADA (2010 ADA 604.2). Unit 98 is designated as a mobility accessible dwelling and subject to ADA design requirements. The toilet position in the accessible bathroom is positioned 19 inches from the sidewall. Additional mobility accessible dwelling units were not inspected but may also be affected.

- **Corrective Action:** Please provide an architect’s or accessibility specialist’s certification with photographic evidence that the condition has been corrected at the location cited and at all other mobility accessible dwelling units (one sample photo only). The certification must verify that every mobility unit has at least one fully accessible bathroom that provides each of the following conditions: 1) toilet is located in the corner of the bathroom; 3) grab bar reinforcement is provided in the back wall for a minimum 36 inch grab bar and extends to at least 42 inches from the corner; 3) grab bar reinforcement is provided in the sidewall for a 42 inch grab bar and extends to at least 54 inches from the corner; 1) the centerline of the toilet is positioned in a range of from 16 to 18 inches from the sidewall ADA.

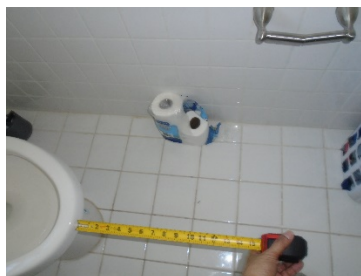
Item #19 Deficiency: Toilet Paper Dispensers (2010 ADA 604.7) Unit 98 is designated as a mobility accessible dwelling unit and subject to ADA design requirements. The toilet paper dispenser in the bathroom is not installed in an accessible location relative to the toilet. It was measured at 17 inches from the front of the toilet to the centerline of the dispenser. Additional mobility accessible dwelling units were not inspected but may also be affected.

- **Corrective Action** – Please provide an architect’s or accessibility specialist’s certification with photographic evidence that the condition has been corrected in the cited unit and all other mobility accessible dwelling units. The certification must verify that the toilet paper dispenser in all accessible bathrooms meets the following conditions: 1) does not control delivery or prevent continuous paper flow; 2) centerline is located between 7 and 9 inches in front of the toilet bowl; 3) outlet is between 15 and 48 inches above the floor; and 4) is no less than 1½ inches to the bottom and no less than 12 inches to the top of the grab bar.

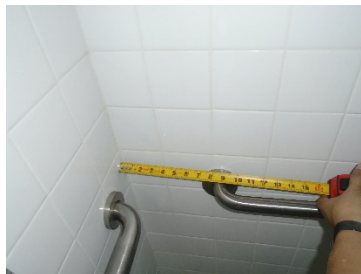
Item #20 Deficiency: Roll-in Shower Grab Bars (2010 ADA 608.3.2) Unit 99 is designated as a mobility accessible dwelling unit and subject to ADA design requirements. The grab bar wall reinforcement located at the back wall of the shower is not positioned correctly in relation to the corner. Additional mobility accessible dwelling units were not inspected but may also be affected.

- **Corrective Action** – Please provide an architect’s or accessibility specialist’s certification with photographic evidence that the condition has been corrected in the cited unit and all other mobility accessible dwelling units. The certification must verify that all of the following installation requirements have been met for roll-in shower grab bars that are currently installed, or, if not installed, that wall reinforcement has been installed in walls and located so as to permit the installation of accessible grab bars that meet all of the following features: 1) grab bars are installed no more than 6 inches from the corner of adjacent walls.

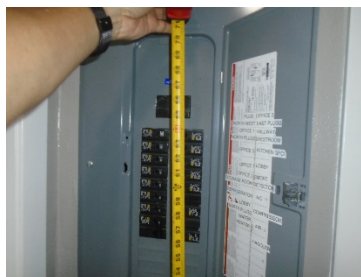
Item #8 Deficiency: Controls and Outlets (2010 ADA 205, 308-9) The office is identified as a common use facility and employee work area and subject to ADA design requirements. The breaker box top switch is 64 inches above the floor surface and is not within accessible reach ranges.

- **Corrective Action** – Provide an architect’s or accessibility specialist’s certification with photographic evidence that the breaker box switches at this location have been corrected or are already correct, are on an accessible route and, where the clear floor space is positioned for an (a)unobstructed front (forward) approach, the height of the switches is 15-48 inches above the floor surface (b)

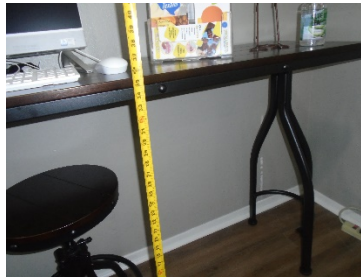
Item #9 Deficiency: Tables & Work Surfaces (2010 ADA 226, 902) The Office is identified as a common use facility and subject to ADA design requirements. The common use computer desk at the business center does not provide an accessible height working surface.

- **Corrective Action** –Please provide an architect’s or accessibility specialist’s certification with photographic evidence that the condition has been corrected at the location cited. The certification must verify that at least 5% of all common use work surfaces on the property(ADA) and specifically verifies that the following design features are provided for each accessible work surfaces: 1) a minimum 30 inch by 48 inch clear floor or ground space provides one unobstructed side located adjacent to the accessible route for the property, and is positioned for a forward (front) approach; 2) top surface is 28 to 34 inches high; and 3) open space beneath accessible tables and work surfaces provides the required knee, leg and toe clearances.

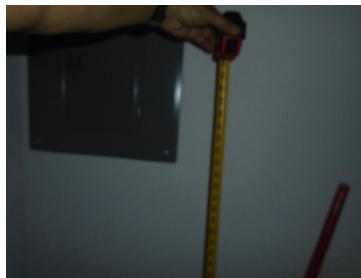
Item #11 Deficiency: Operable Parts (2010 ADA 205, 308-9) Units 49 and 51 are identified as mobility accessible dwelling units and subject to ADA design requirements. The unit breaker box switch is not within accessible reach ranges. Additional mobility accessible dwelling units were not inspected but may also be affected.

- **Corrective Action** – Provide an architect’s or accessibility specialist’s certification with photographic evidence that the breaker boxes at the cited unit and all other mobility accessible dwelling and units have been corrected or are already correct. The certification must verify that accessible breaker boxes and are on an accessible route, and, where the clear floor space is positioned for an (a)unobstructed front (forward) approach, the height of the switch is 15-48 inches above the floor (b)unobstructed side (parallel) approach, the height of the switch is 15-48 inches above the floor (an object that is less than or equal to 34 inches high and less than or equal to 10 inches deep is not considered an obstruction).

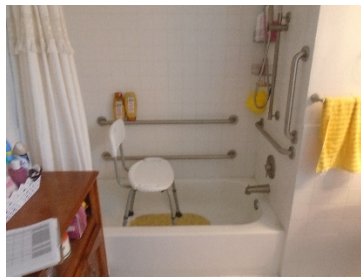
Item #14 Deficiency: Bathtub Controls (2010 ADA 607.5) Unit 49 is designated as a mobility accessible dwelling unit and subject to ADA design requirements. The bathtub controls in the accessible bathroom are not located offset from the bathtub centerline on the open side of the bathtub. Additional mobility accessible dwelling units were not inspected but may also be affected.

- **Corrective Action** – Please provide an architect’s or accessibility specialist’s certification with photographic evidence that the condition has been corrected in the cited unit and all other mobility accessible dwelling units. The certification must verify that the bathtub controls meet all of the following conditions: 1) located on an end wall; 2) offset from the bathtub centerline on the open side of the bathtub; 3) located between the bathtub rim and the existing grab bar or the correct mounting location for a grab bar; 3) at least 1½ inches of clearance is provided between the controls and adjacent objects; and 4) requires one hand to operate with no tight grasping, pinching or twisting of the wrist.
