What is NSPIRE?

NSPIRE Applicability

The 63 NSPIRE Standards

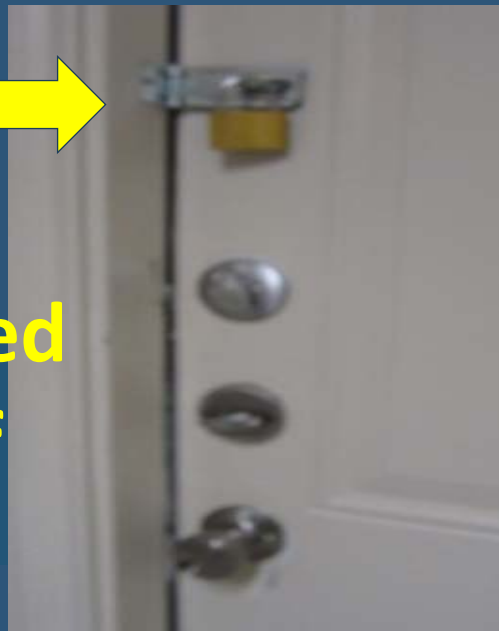
**Obstructed
Means of
Egress**

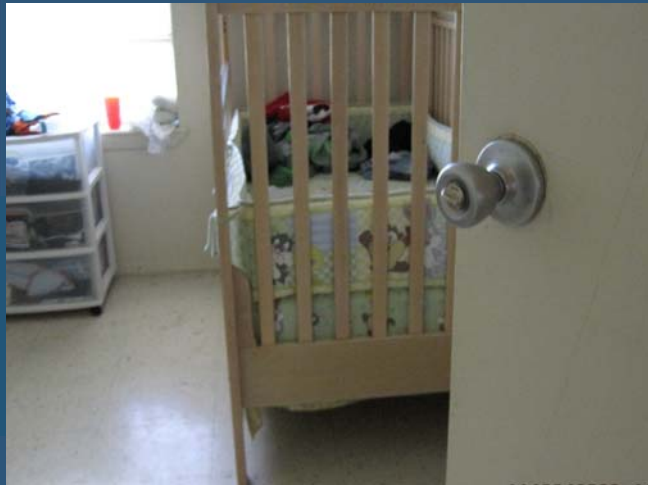
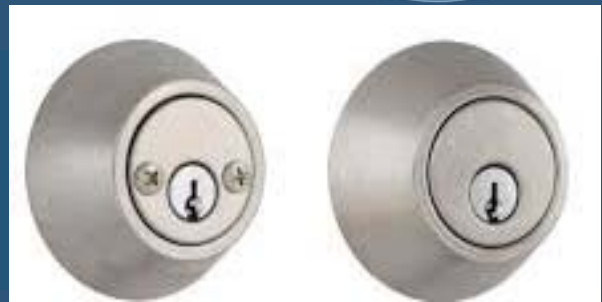
Life-Threatening and Severe Obstructed means of egress

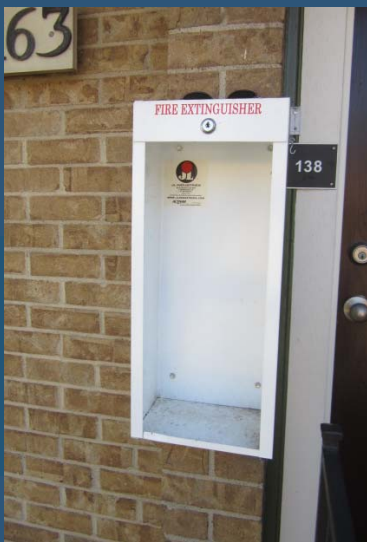
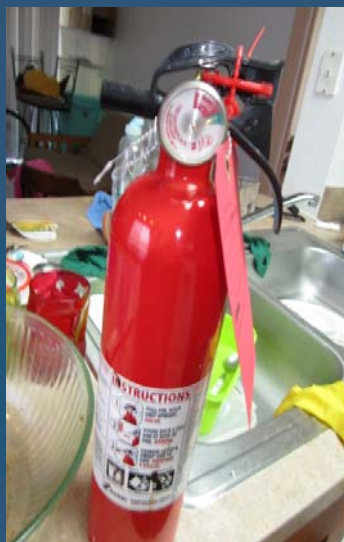
Life-Threatening and Severe Missing/damaged/expired fire extinguisher

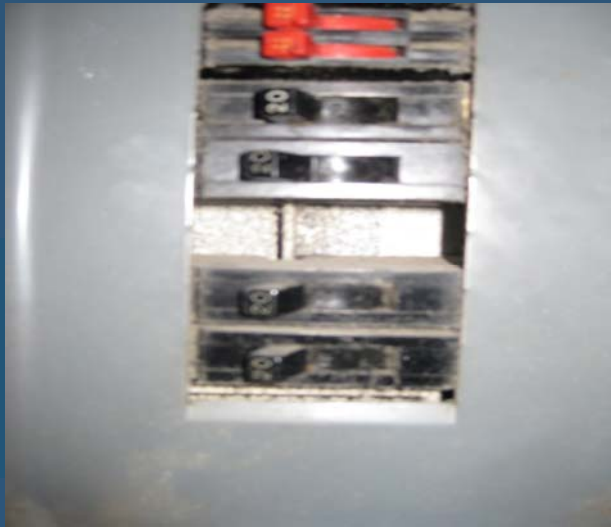
Life-Threatening and Severe EXPOSED ELECTRICAL CONDUCTOR

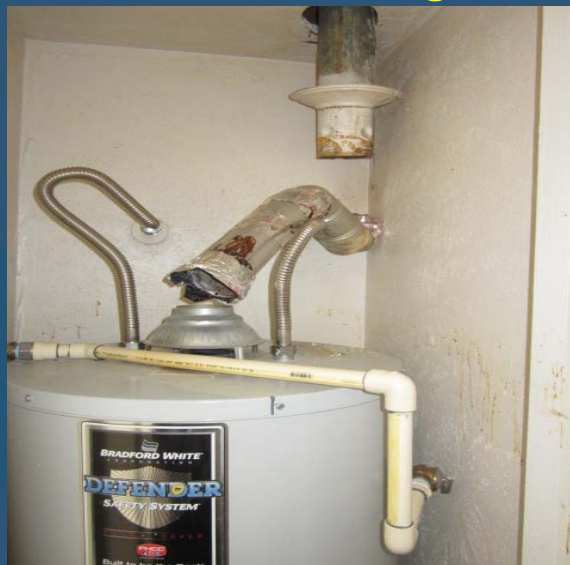
Life-Threatening and Severe Carbon Monoxide Hazard/Misaligned Chimney:

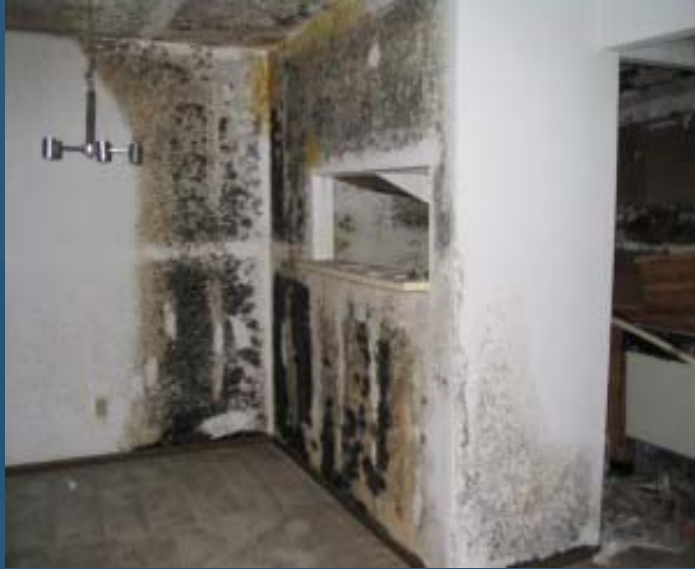
Life-Threatening and Severe: Mold-Like Substance Standard

Deficiency: Presence of mold-like substance at extremely high levels is observed visually. Cumulative area of patches is more than 9 square foot in a room

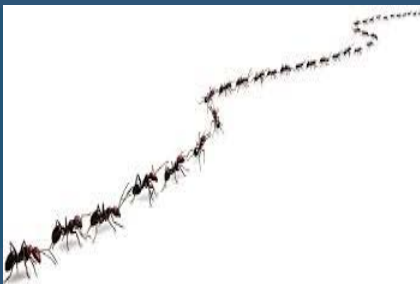
Life-Threatening and Severe Infestation

Deficiency: Evidence of cockroaches, bedbugs, mice and rats

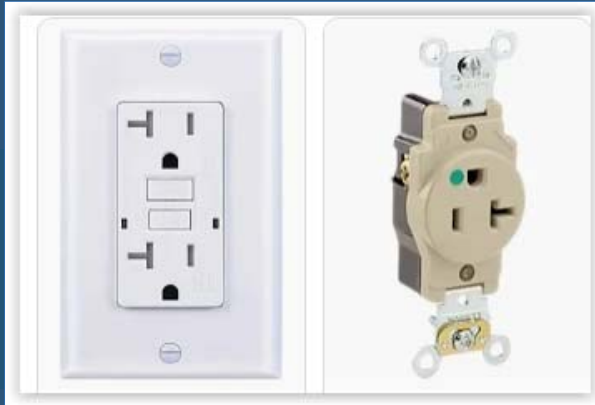
- The outlet must be GFCI protected or a dedicated outlet.

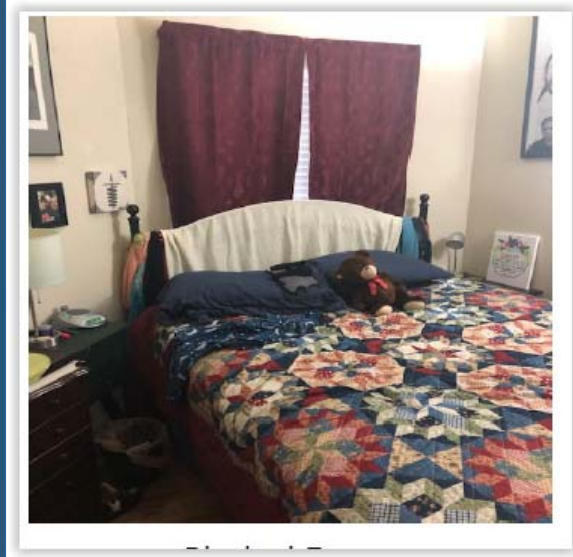
Resident owned property is not evaluated as an obstruction.

DEFICIENCY CRITERIA:	Sleeping room is located on the 3 rd floor or below and has an obstructed rescue opening.	
HEALTH AND SAFETY DETERMINATION:	Life-Threatening	The Life-Threatening category includes deficiencies that, if evident in the home or on the property, present a high risk of death to resident.
CORRECTION TIMEFRAME:	24 hours	
HCV PASS / FAIL:	Fail	
HCV CORRECTION TIMEFRAME:	24 hours	
INSPECTION PROCESS:		
OBSERVATION:	<ul style="list-style-type: none"> - Identify rooms used for sleeping. - Visually inspect for any obstructed rescue opening. 	
REQUEST FOR HELP:	- None	
ACTION:	- Verify the rescue opening fully opens.	
MORE INFORMATION:	<ul style="list-style-type: none"> - If there is a fire escape adjacent to the rescue opening, then evaluate under Deficiency 3. - Resident-owned property should not be evaluated as an obstruction to the rescue opening. - The following are examples of conditions that may obstruct a rescue opening: <ul style="list-style-type: none"> - Window locks that require a key, a tool, or special knowledge or effort to operate (from the interior). - When fixed security bars are present that cover a window that is the designated rescue opening from the building. - Any lock on movable security bars for windows requiring a key (special tool) to open, whether locked or unlocked at the time of inspection. - Placement of an item or furniture that is not resident owned and obstructs a rescue opening. - A permanently installed window-mounted air conditioner.

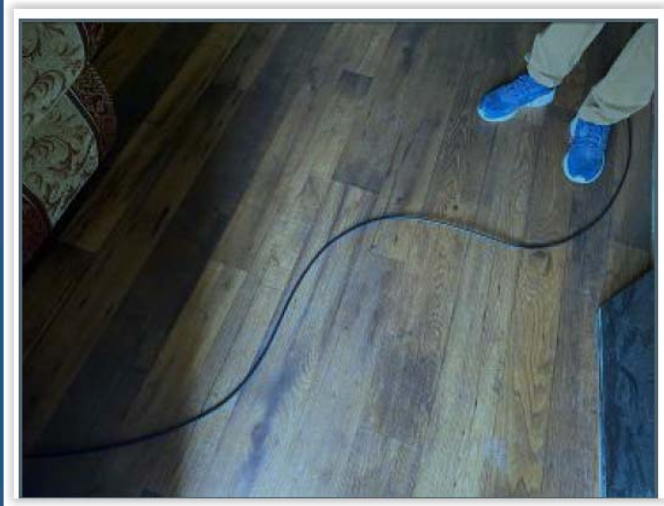
Must be greater than ¾ in vertical difference.

DEFICIENCY I — UNIT:	TRIP HAZARD ON WALKING SURFACE.
DEFICIENCY CRITERIA:	<p>There is an abrupt change in vertical elevation or horizontal separation on any walking surface along the normal path of travel, consisting of the following criteria:</p> <ul style="list-style-type: none"> - An unintended ¾-inch or greater vertical difference. OR - An unintended 2-inch or greater horizontal separation that is perpendicular to the path of travel.
HEALTH AND SAFETY DETERMINATION:	<p>Moderate The Moderate Health and Safety category includes deficiencies that, if evident in the home or on the property, present a moderate risk of an adverse medical event requiring a healthcare visit, cause temporary harm, or if left unmitigated, cause or worsen a chronic condition that may have long-lasting adverse health effects; or that the physical security or safety of a resident or their property could be compromised.</p>

CORRECTION TIMEFRAME:	30 days
HCY PASS / FAIL:	Fail
HCY CORRECTION TIMEFRAME:	30 days
INSPECTION PHASES:	<p>OBSERVATION: - Look at the walking surface along the normal path of travel to identify a significant difference in vertical elevation or horizontal separation.</p> <p>REQUEST FOR HELP: - None</p> <p>ACTION: - If identified, measure to determine if there is a ¾-inch or greater vertical separation or 2-inch or greater horizontal separation.</p> <p>MORE INFORMATION: - Examples of conditions that should be evaluated under this deficiency include, but are not limited to: - A service access cover that is missing and it is located along a walking surface. - Any surface, object, or material that creates an unintended ¾-inch or greater vertical rise along the path of travel. - An unintended 2-inch or greater gap or space along the path of travel. - Examples of conditions that should not be evaluated under this deficiency include, but are not limited to: - An engineer-designed gap or vertical difference (e.g., a raised manhole or a plant grate designed in the middle of a path of travel). - An intentional transition from a walking surface to a doorway or entrance.</p>

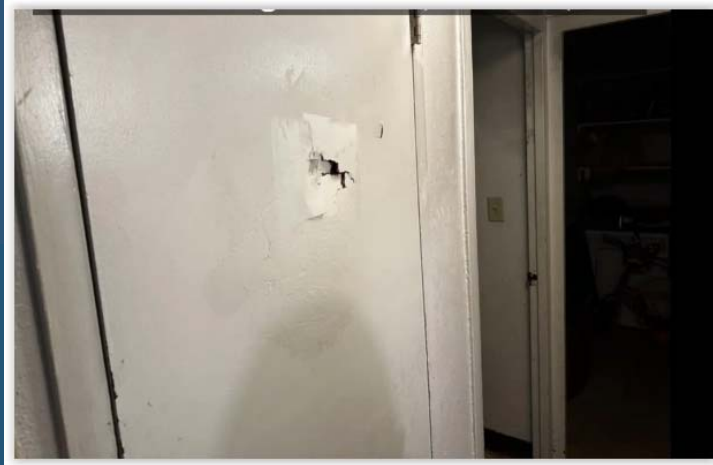
Passage Door, not an Entry or Fire-Labeled door.

- As bad as this looks, No Deficiency.
- A passage door is a door between rooms, door into a walk-in closet, or door into a utility room, storage room, or room that contains washers and dryers.
- Door must open, close, latch (operates as intended) and privacy is not compromised.

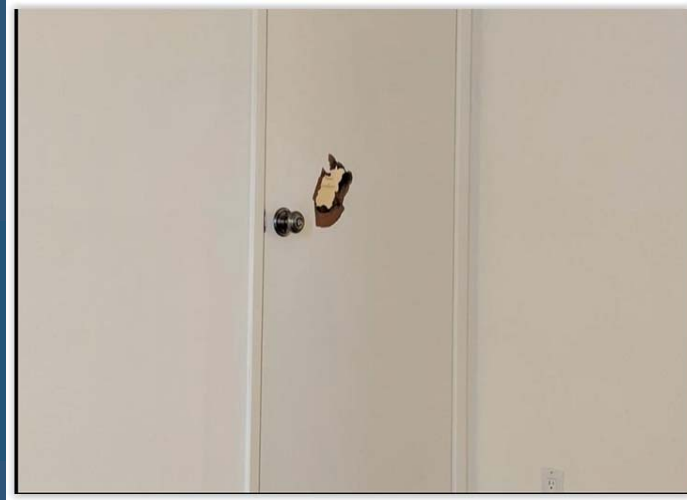
Yes, privacy has been compromised.

DEFINITION:	Panel that provides an opening in a building or room and provides separation (i.e., closes an opening).	
PURPOSE:	Provides privacy, manages the atmosphere inside a room (e.g., heating and cooling), and may prevent the spread of fire or smoke.	
COMMON COMPONENTS:	Frame; Sill; Jamb; Handle; Door sweep; Lock set; Threshold; Hinge; Casing	
LOCATION:	<input checked="" type="checkbox"/> Unit	All passage doors throughout the Unit (i.e., a door between rooms, door into a walk-in closet, or door into a utility room, storage room, or room that contains washers and dryers).
	<input checked="" type="checkbox"/> Inside	All passage doors throughout the Inside (i.e., a door between rooms, door into a walk-in closet, or door into a utility room, storage room, or room that contains washers and dryers).
	<input checked="" type="checkbox"/> Outside	All exterior doors throughout the Outside (i.e., a door into a utility room, storage room, or mechanical room).

MORE INFORMATION:	Privacy within a bathroom should be evaluated under the Toilet standard and Bathtub and Shower standard, respectively.	
<hr/>		
DEFICIENCY 1:	A passage door does not open.	
LOCATION:	<input checked="" type="checkbox"/> Unit	<input checked="" type="checkbox"/> Inside
<hr/>		
DEFICIENCY 2:	A passage door component is damaged, inoperable, or missing and the door is not functionally adequate.	
LOCATION:	<input checked="" type="checkbox"/> Unit	<input checked="" type="checkbox"/> Inside
<hr/>		
DEFICIENCY 3:	A door that is not intended to permit access between rooms has a damaged, inoperable, or missing component.	
LOCATION:	<input checked="" type="checkbox"/> Unit	
<hr/>		
DEFICIENCY 4:	An exterior door component is damaged, inoperable, or missing.	
LOCATION:	<input checked="" type="checkbox"/> Outside
